January 07, 2010

RE: Greenback School – Loudon County, TN
Structural Walkthrough – Visual Inspection of Facility
Report of Findings
HODGE Associates Job # 2564

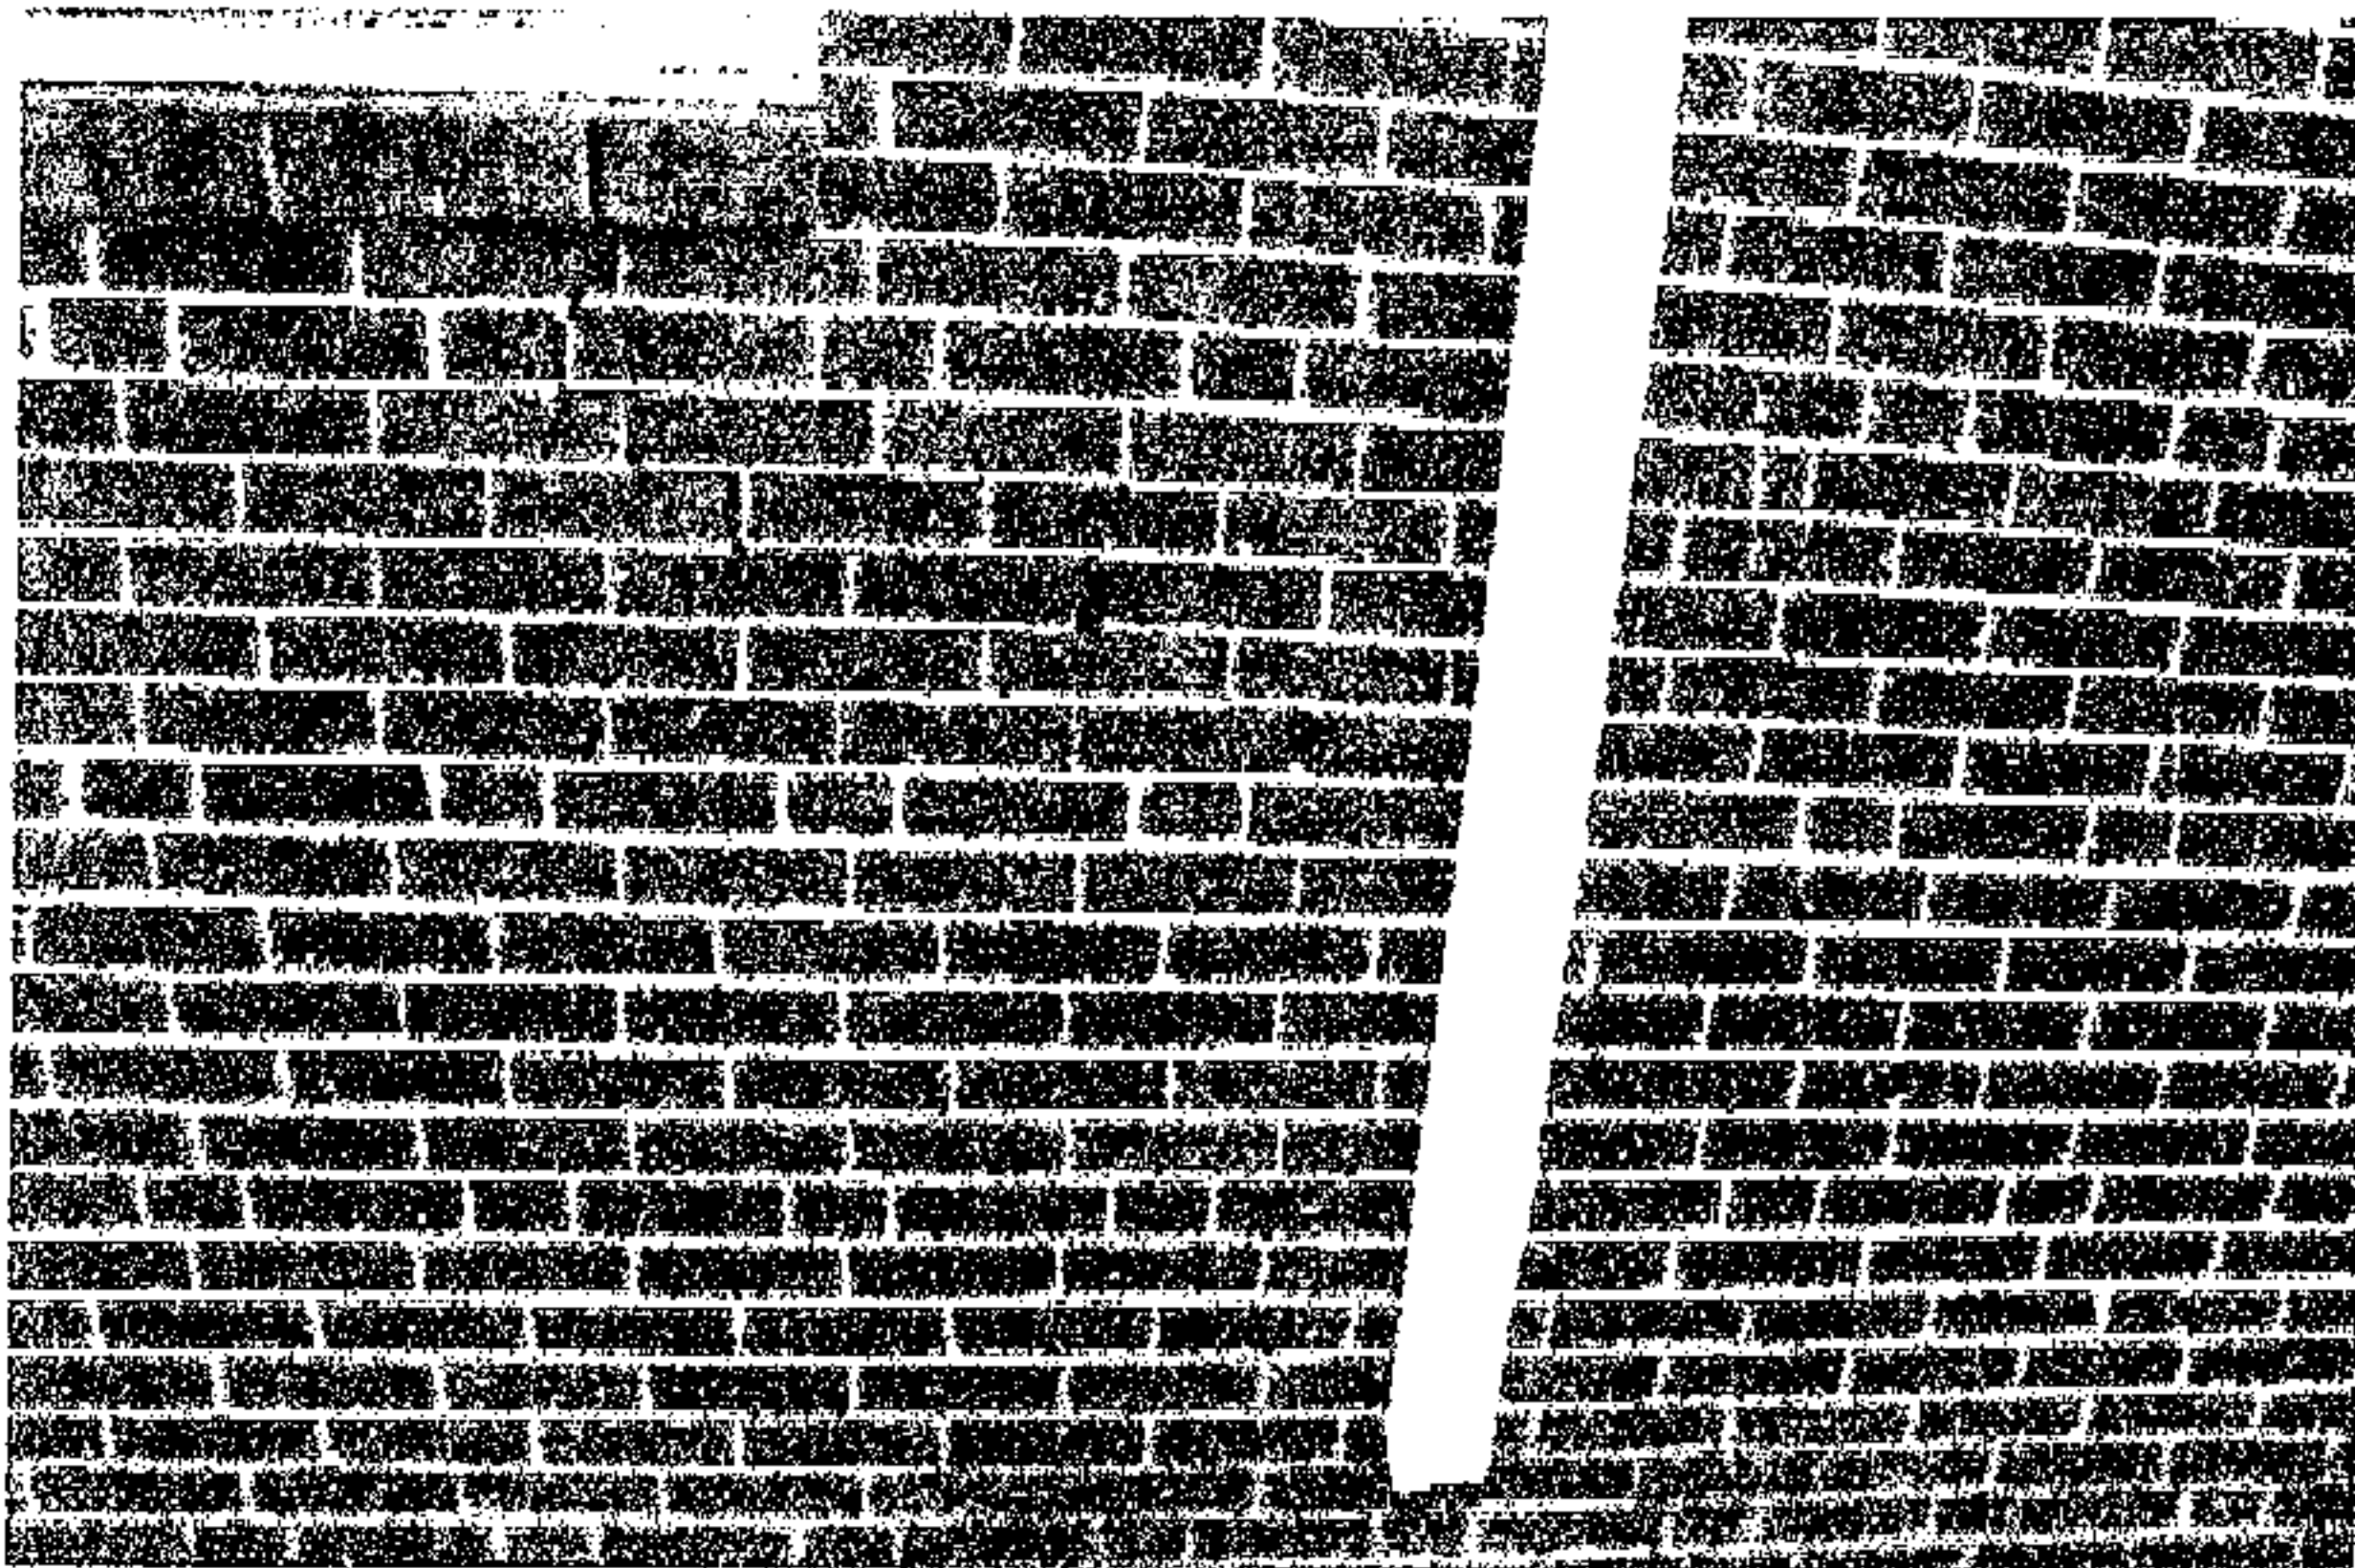
A number of masonry cracks exist throughout the entire facility primarily due to an inadequate storm drainage system. Gutters and downspouts have not been maintained, and therefore allow water to accumulate at the foundations. Saturated soils become weak and precipitate localized settlement of the foundations. Walls bearing on settled foundations will incur stair-step cracks in the mortar joints. Horizontal displacement of the façade can occur in severe cases as shown in photo #16. The collapsed portion of the gutter along the north wall of the oldest building is contributing to the flooding of the basement (see photo #15). The mildew stained brick façade and rotting windowsills of the courtyard Middle School windows is attributed to leaking gutters. Gutters and downspouts must be repaired and replaced as necessary to direct water away from the structure. If left unattended, the poor storm water management may compromise the structural integrity of the foundations and could facilitate damage to other building components.

3. Downspout with settlement crack.

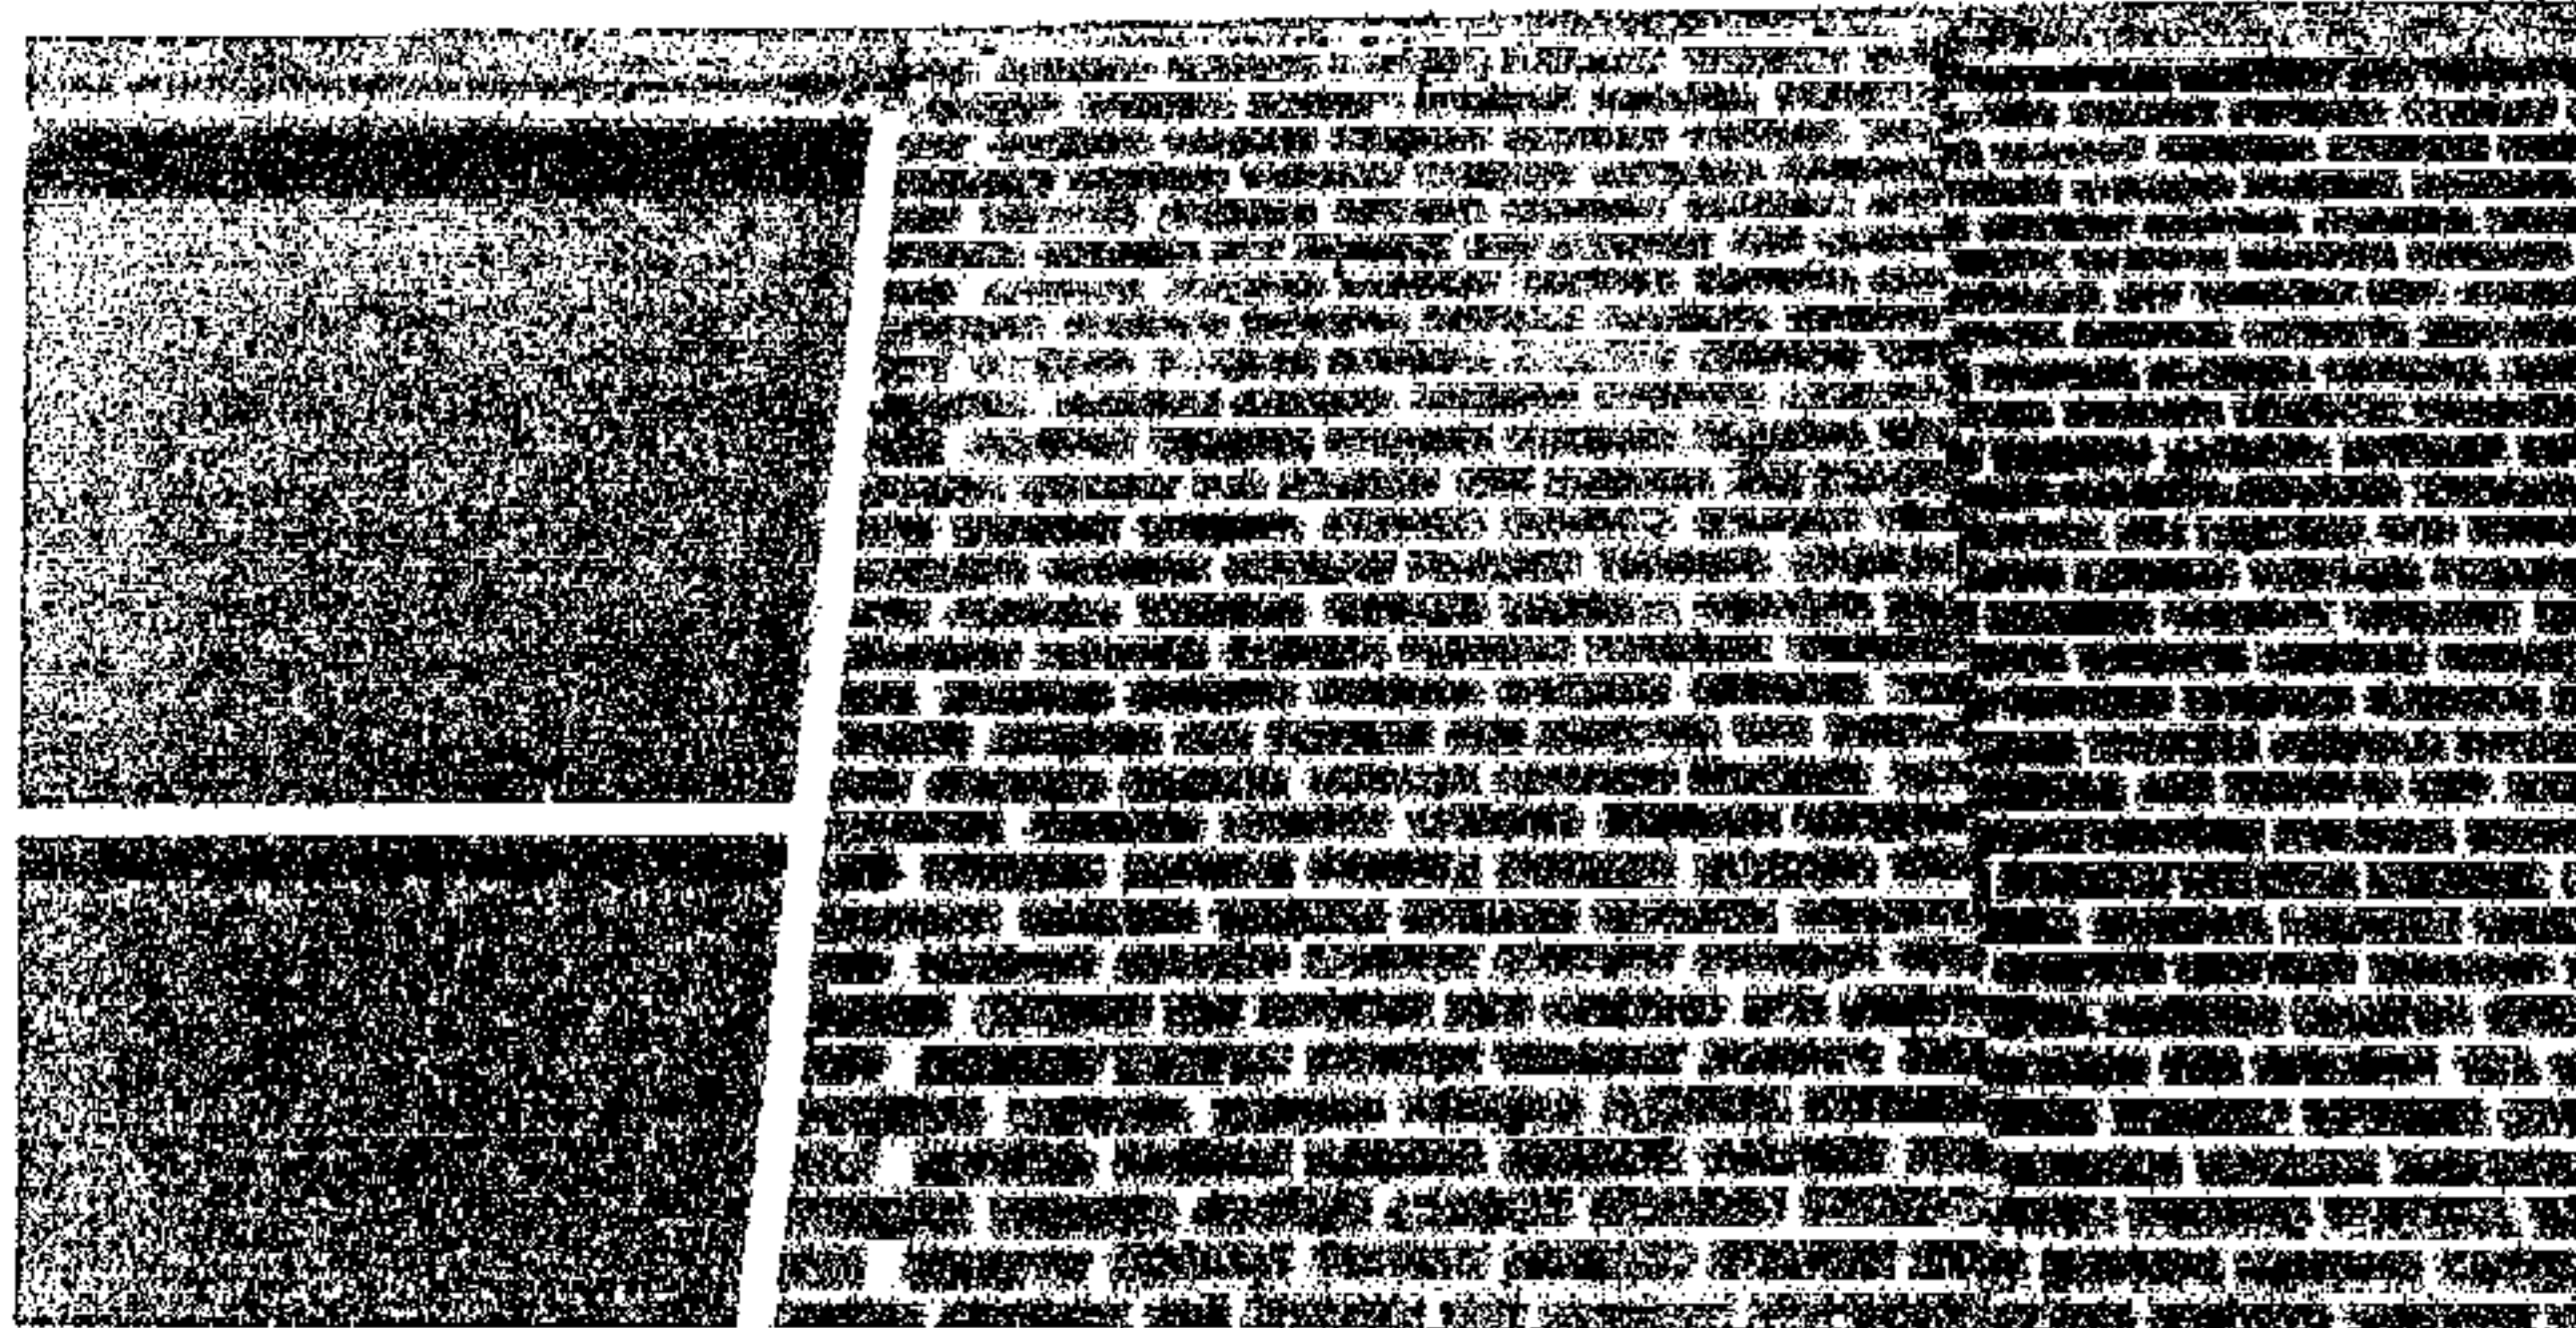
A single steel roof joist of the gymnasium as part of the physical education building is showing signs of excessive shear stress at the bearing seats. Cracks exist where the joist bears on the wall. The cracks extend down the wall at a 45 degree angle and include both interior CMU and exterior brick. See photos #4 and #5 for location. HA suggests the existing fractured CMU and brick be removed, and the bearing conditioned repaired. All other joist seats should be closely observed for similar inadequacies.

5. Gymnasium joist shear crack from exterior.

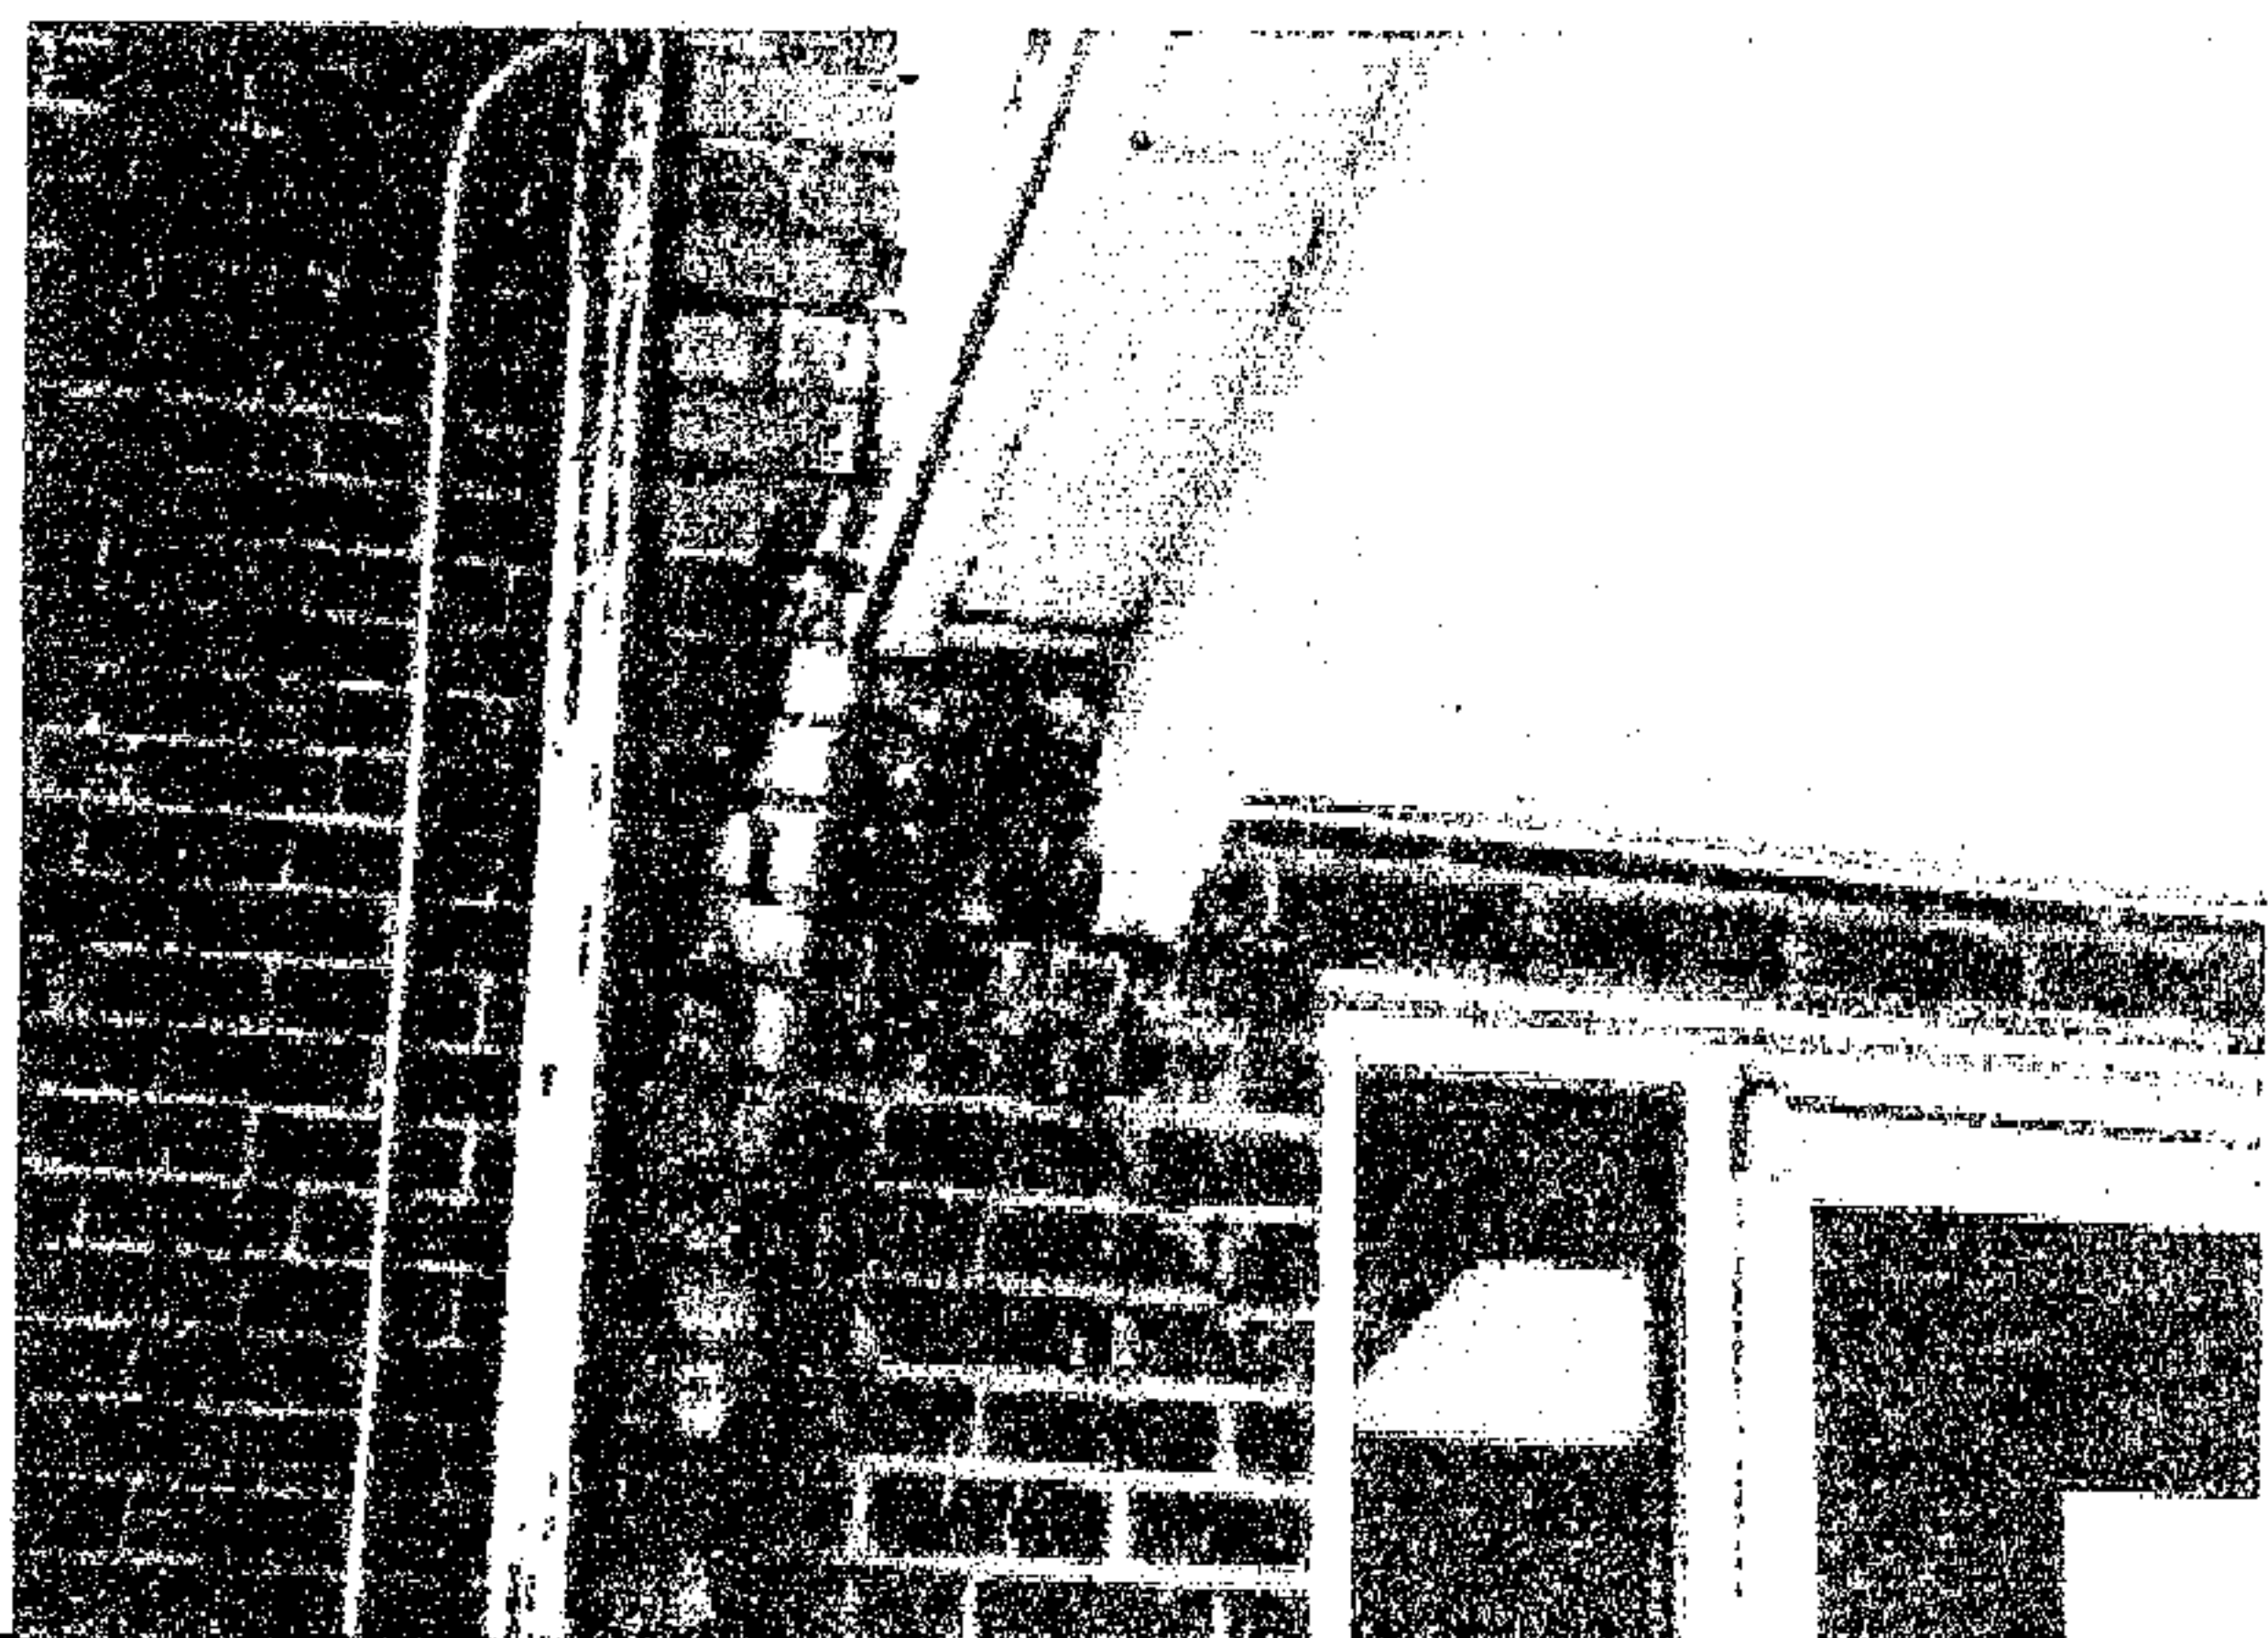
The bearing of the walkway canopy at the west end of the High School is degrading and may become unstable. See photo #12 for location. Freeze/thaw damage may have contributed to the degradation of the bearing seat at the brick wall. HA suggests removing the damaged brick, and repairing the bearing condition as necessary. All other similar bearing conditions should be repaired as necessary.

10. Exterior walkway canopy bearing condition.

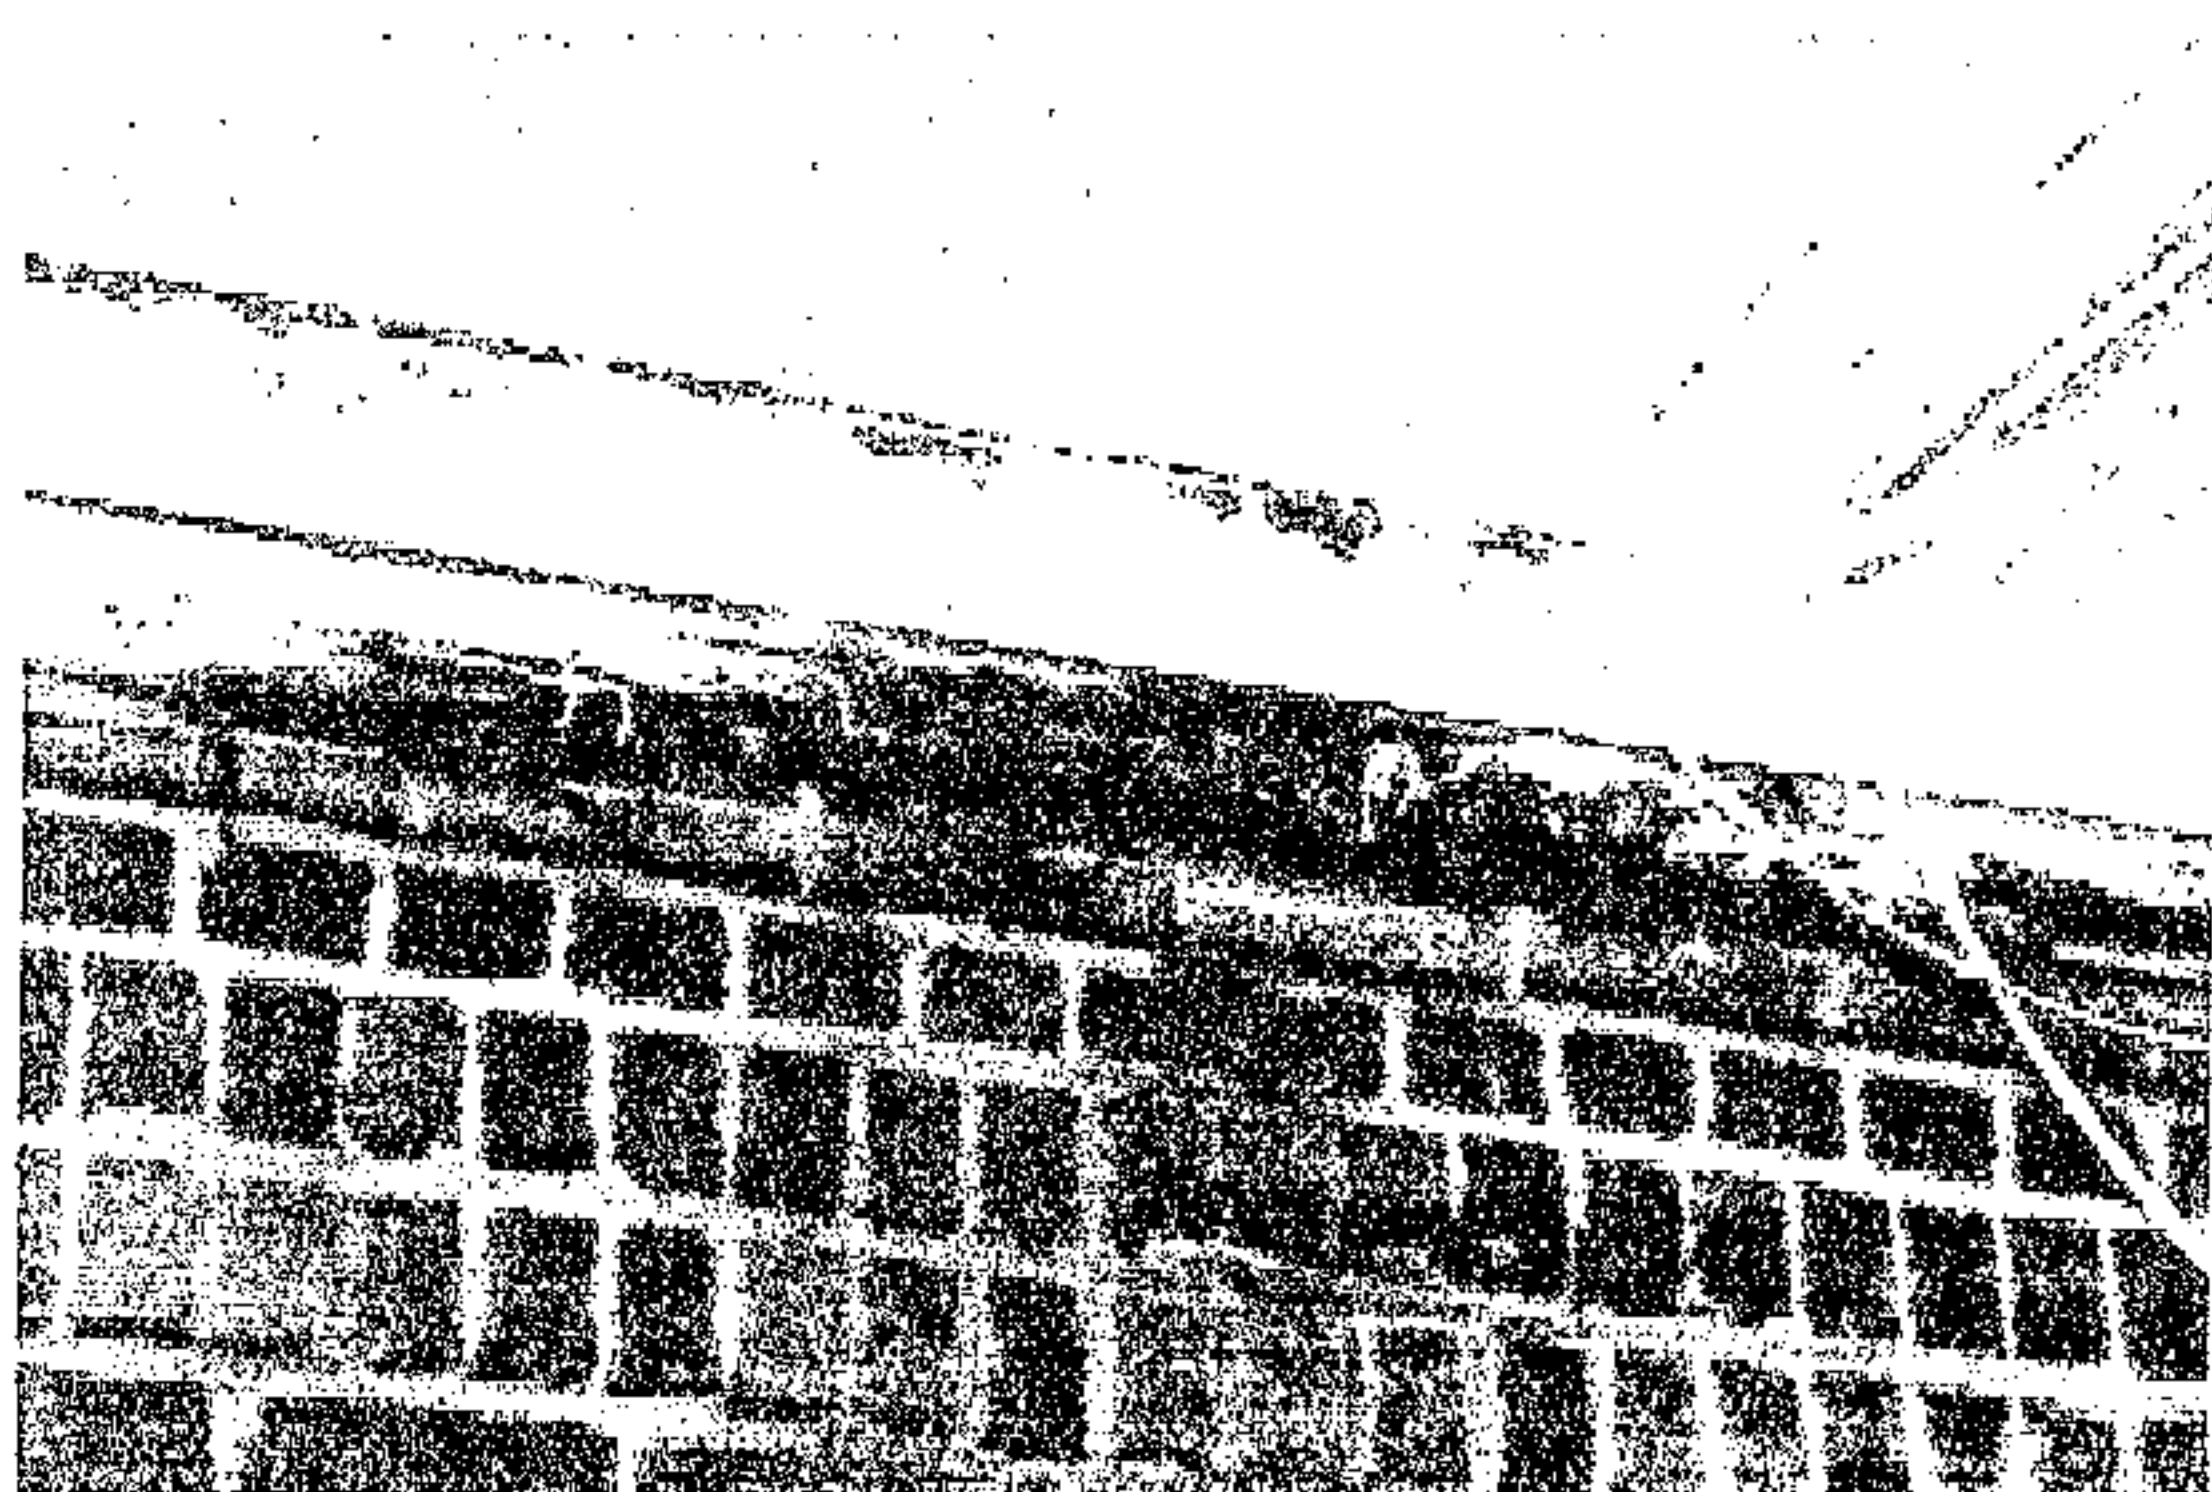
heads. Leaks in the spray foam material may cause the roof deck to rust and therefore compromise its structural integrity. HA suggests a thorough investigation of the roof deck to determine if leaks have occurred. The roof edge detail has allowed water to be in contact with the fascia boards and caused severe wood rot. The rotted fascia boards may allow water behind the brick façade and facilitate the freeze/thaw damage to the brick. The north wall of the High School gymnasium has suffered from freeze/thaw damage as evident from the popped brick faces. The asphalt shingles are nearing the end of their lifespan, and are mildewing which may be allowing leaks. HA highly suggests the consideration of installing a new roof throughout the facility as well as redesigning the edge detail.

11. Rotting fascia boards

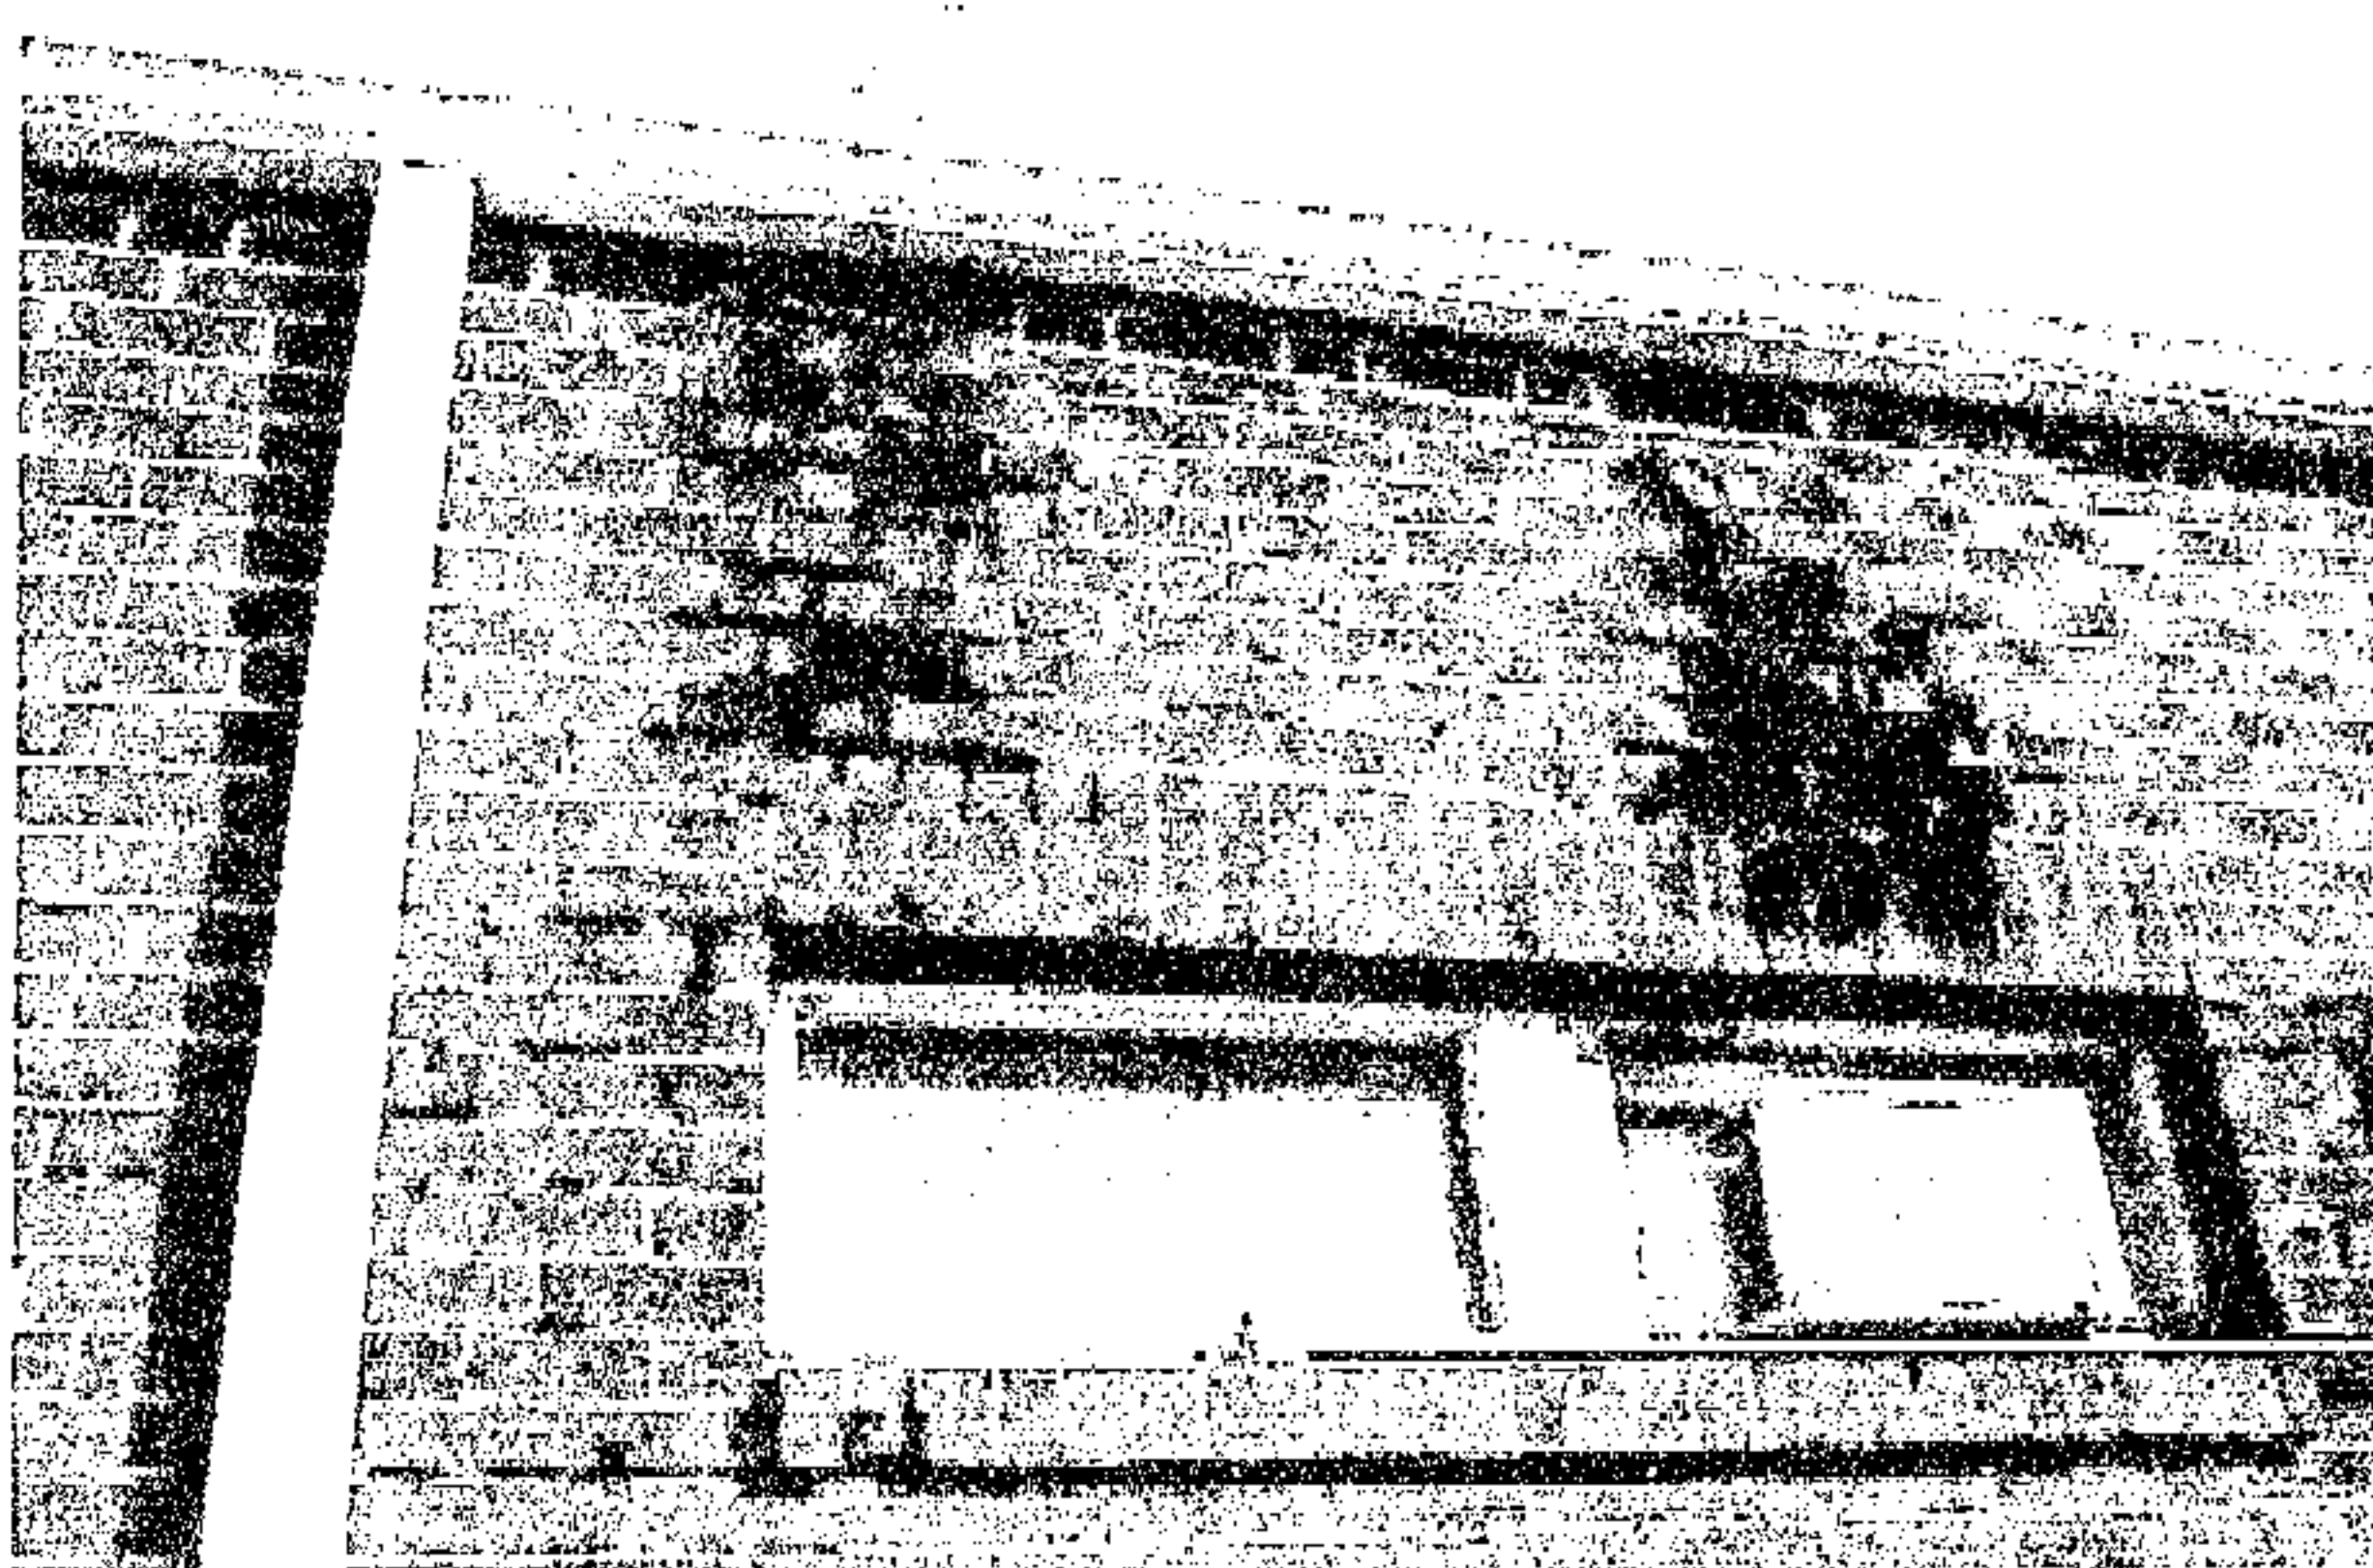
17. Leaking gutter in need of repair.

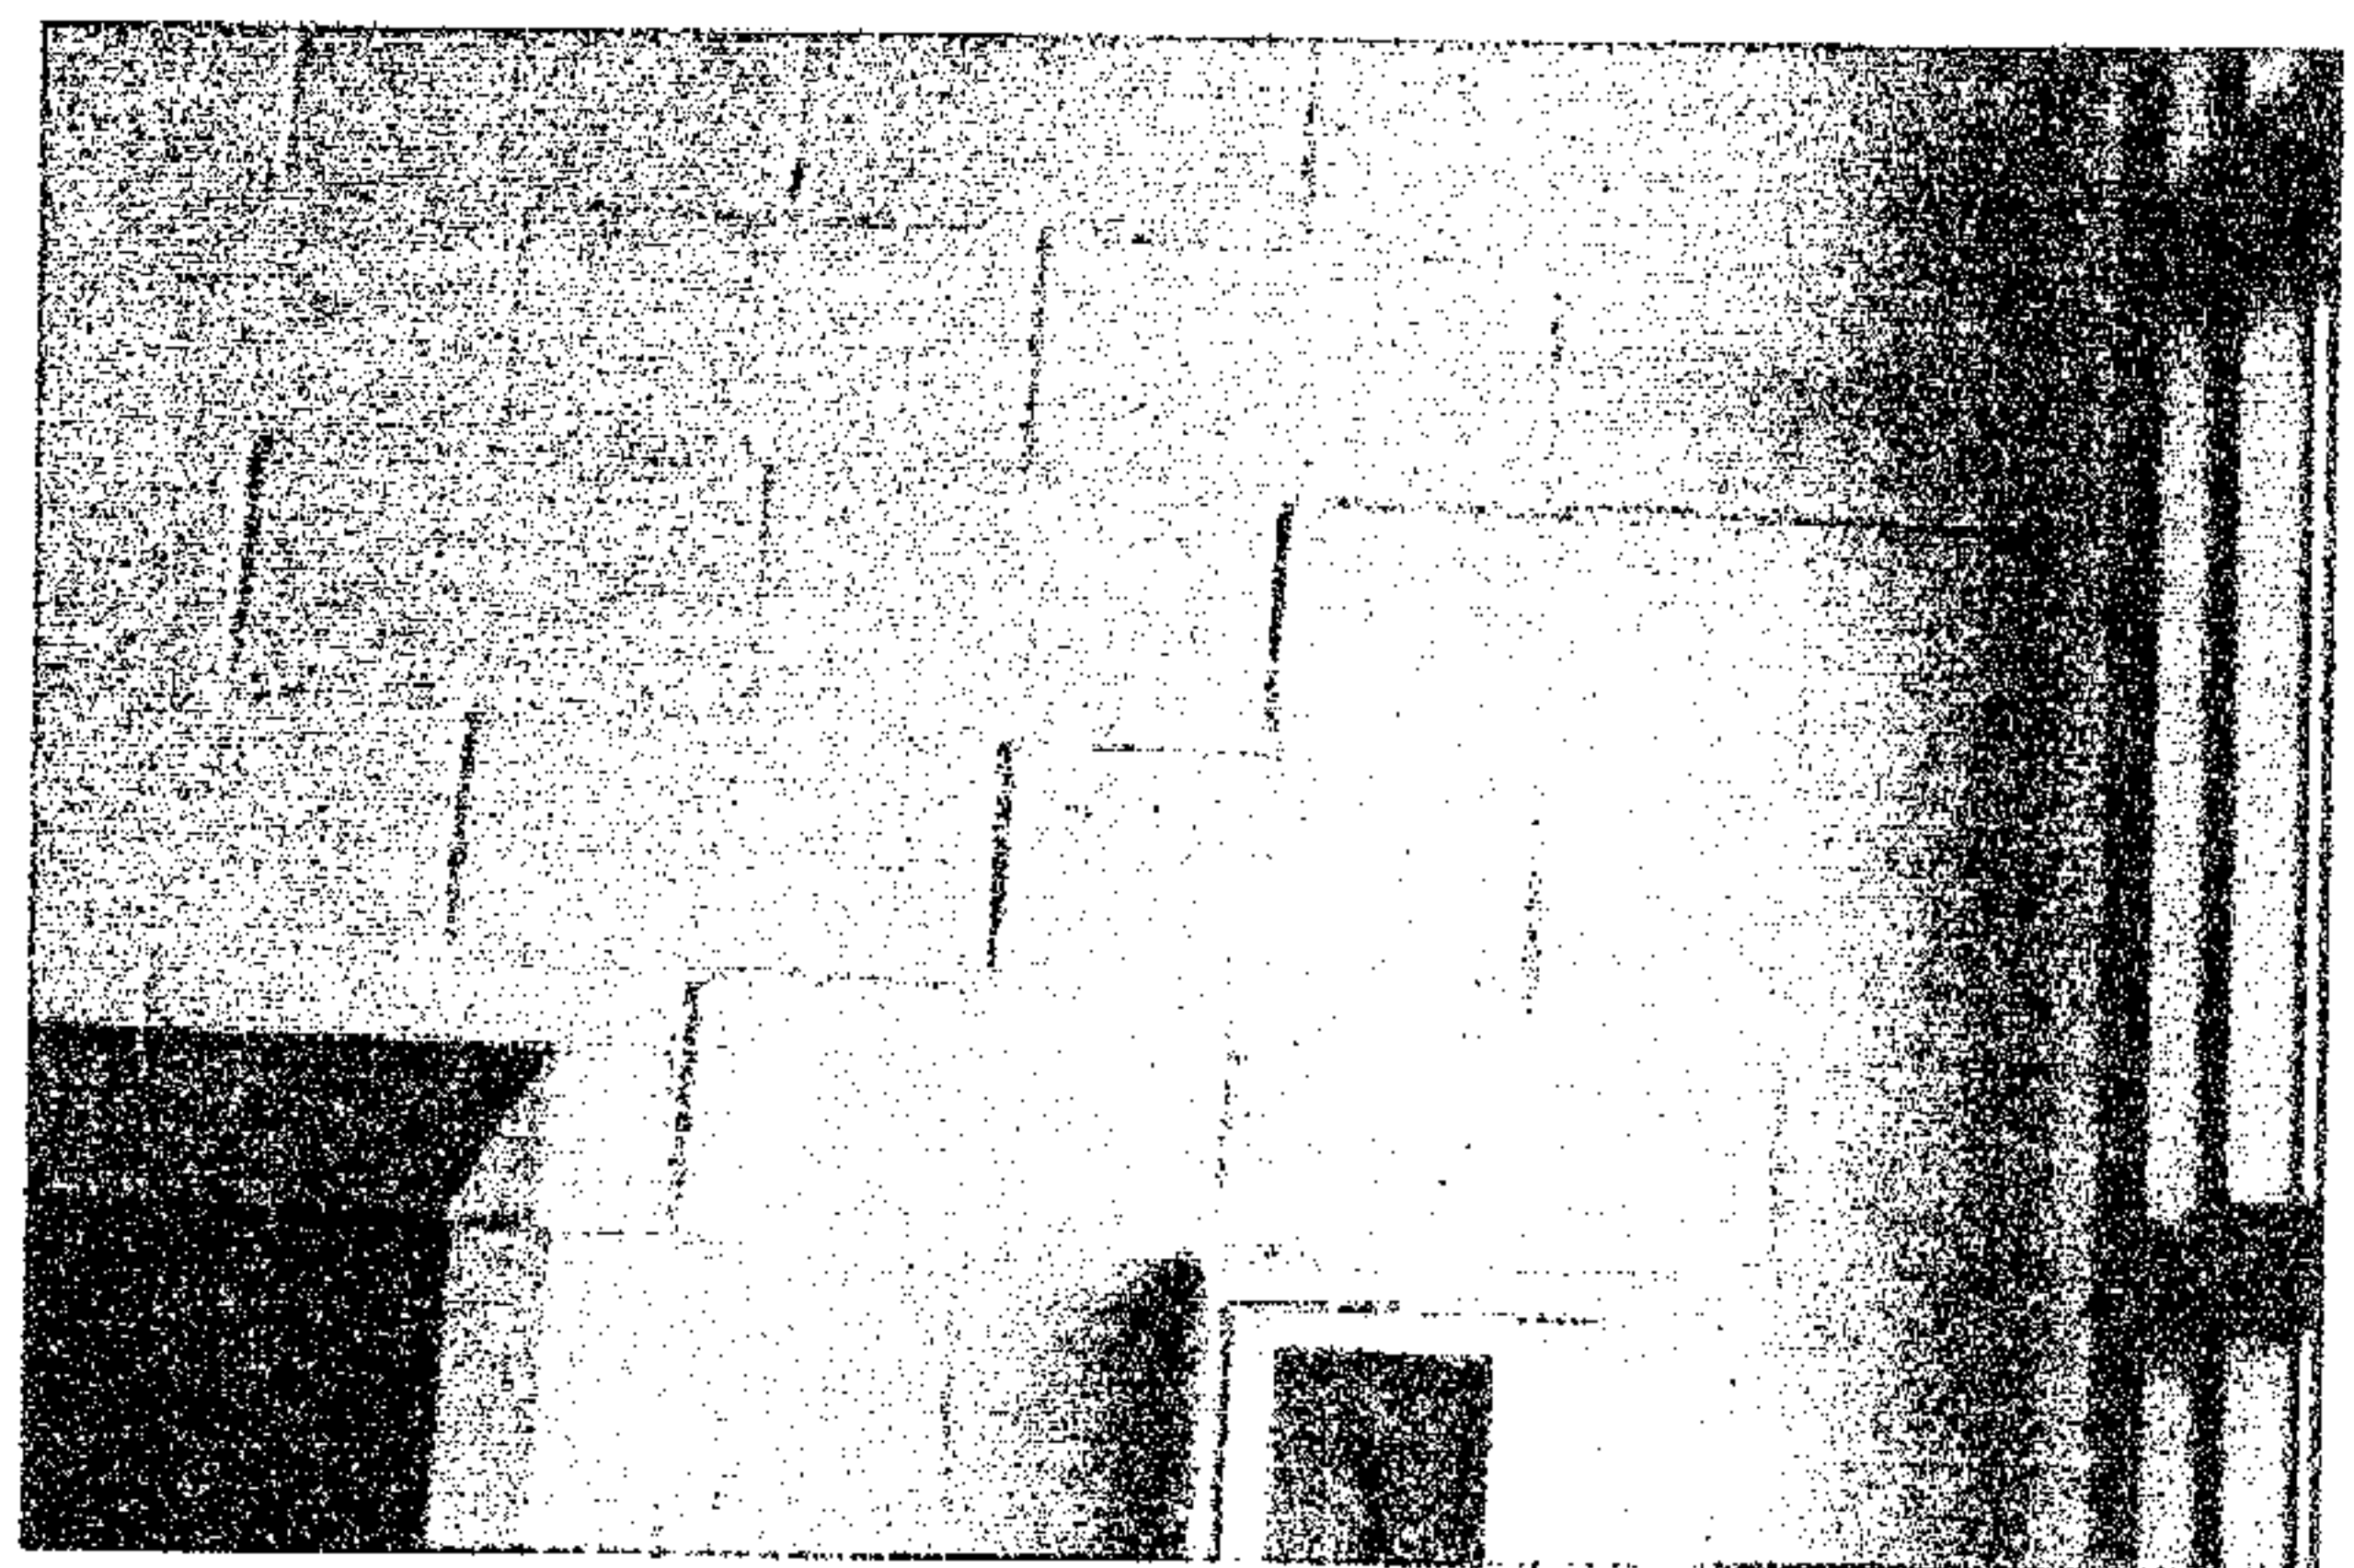
22. Stair Step crack due to foundation settlement.
